Additional Grease Seal and Modified Ball-Cup

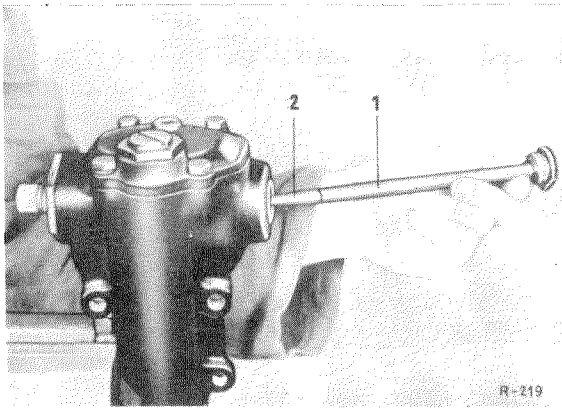
Fig. 46—4/16

- 1 Cable guide tube
- 2 Guide pin

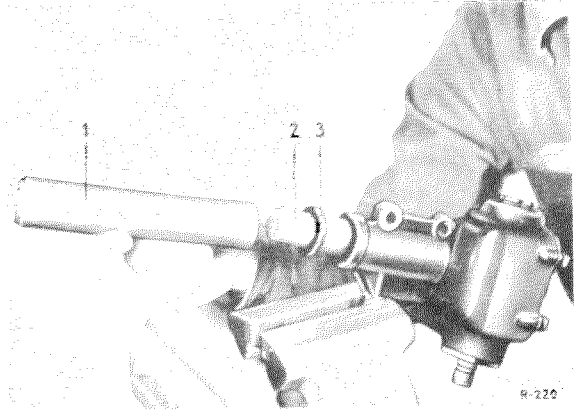
Fig. 46—4/17

- 1 Fitting Sleeve 120 589 06 61
- 2 Guide Sleeve 120 589 05 61
- 3 Grease seal

40. Push Guide Sleeve (2) 120 589 05 61 onto the steering shaft (Fig. 46—4/17).
Then smear sealing compound along the outer circumference of a new grease seal and use Fitting Sleeve (1) 120 589 06 61 to drive it into the housing (Fig. 46—4/17).
41. Press the steering gear arm onto the serrated part of the steering shaft so that the

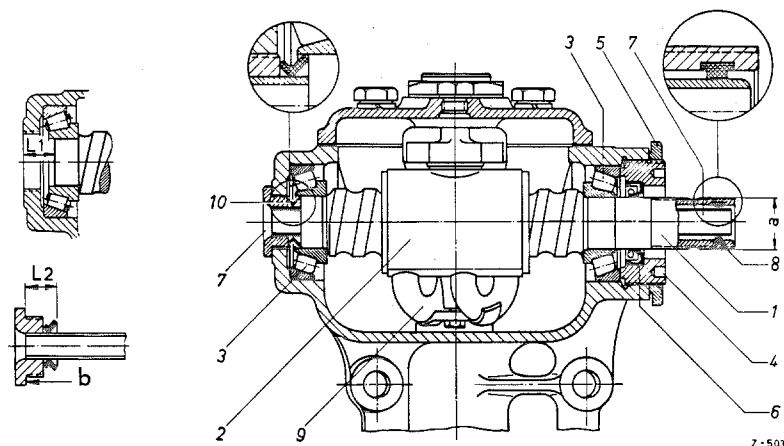
Fig. 46—4/18

- a Diameter at the serrations = 19.6 mm
- b Contact face of cable guide tube
- 1 Steering worm
- 2 Steering nut
- 3 Taper-roller bearing
- 4 Adjusting ring
- 5 Hexagon nut for adjusting ring
- 6 Grease seal in adjusting ring
- 7 Cable guide tube
- 8 Upper sealing ring for cable guide tube
- 9 Ball guide tube
- 10 Lower sealing ring for cable guide tube

In order to obtain improved sealing, as of Steering No. 3764/56, a second grease seal (10), Part No. 120 997 10 40, has been installed between the steering worm and the cable guide tube (Fig. 46—4/18).

When repairs are being carried out, this sealing ring (10) should be subsequently installed whenever necessary. In doing this, care should be taken to ensure that sufficient pressure is used to bring the sealing ring to rest against the steering worm and cable guide tube. The distance $L_1 - L_2$ must be 0.5 — 0.6 mm, i. e. when the cable guide tube is installed, the sealing ring must be compressed approximately 0.5 — 0.6 mm. If this difference in measurements is not obtained, the cable guide tube must be remachined accordingly at its contact surface (b). When the steering is reassembled, the sealing ring (10) should be pressed on before the cable guide tube is inserted, in accordance with Paragraph 39 of the installation instructions (see Fig. 46 — 4/18).

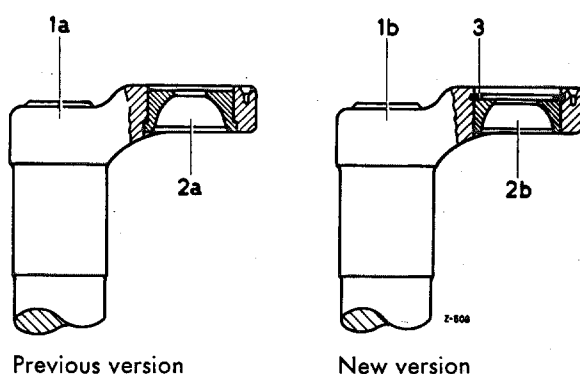
Fig. 46 — 4/19

- 1a Steering shaft with ball-cup with shoulder
- 1b Steering shaft with ball-cup without shoulder
- 2a Ball-cup with shoulder
- 2b Ball-cup without shoulder
- 3 Snap ring

For production reasons, in current models the steering shaft arm has a ball-cup with no shoulder. The new ball-cup (2 b) is locked with a snap ring (3) to prevent displacement (Fig. 46 — 4/19).
