Restoration of a 1959 Mercedes-Benz 220S Ponton sedan

John Brady / Richardson, Texas / johnfbrady3@gmail.com

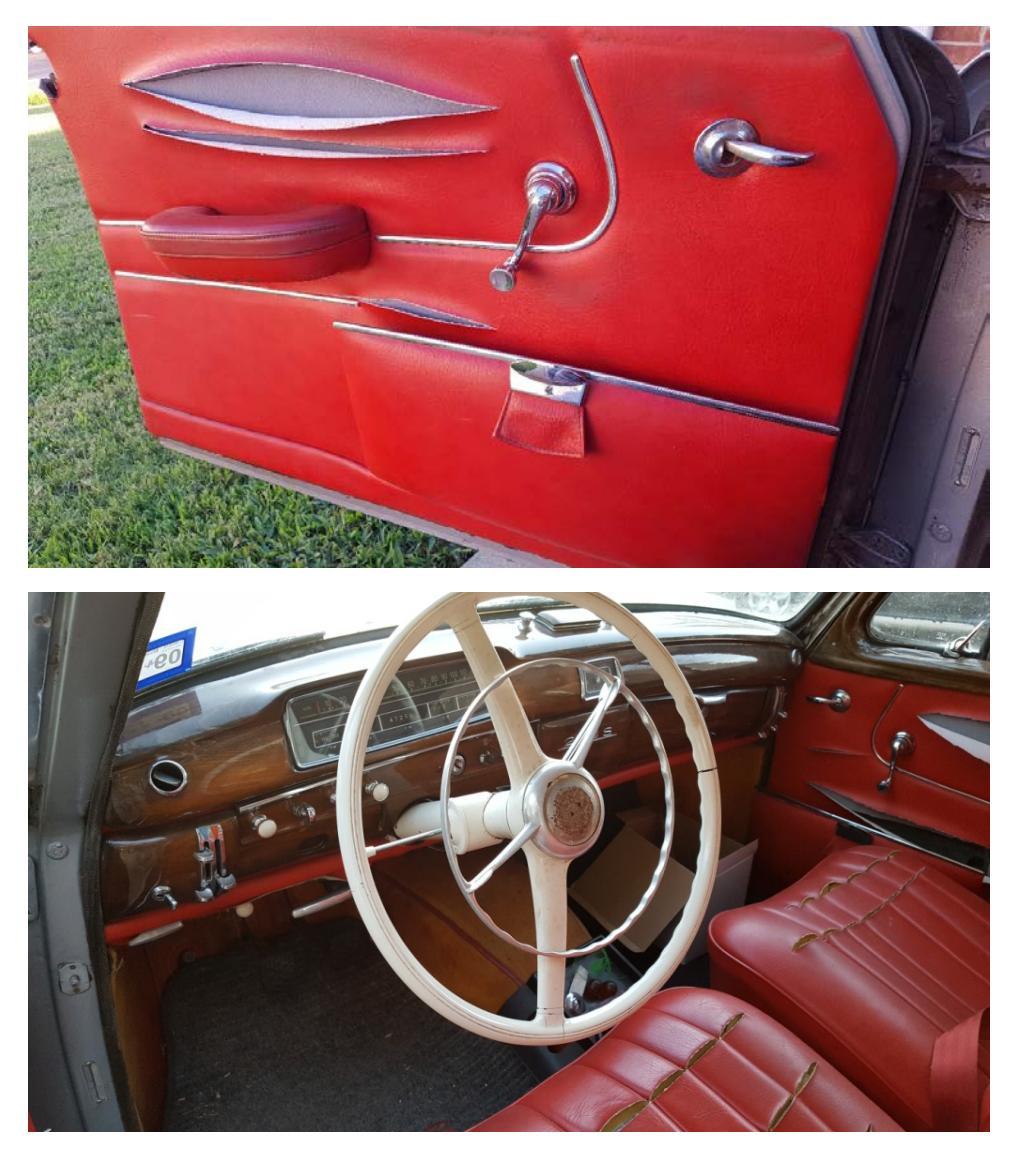
I found the car on Craigslist in Austin, Texas in April 2016. It needed help. We got it started, and fuel was coming out of the fuel pump and both carburetors, but at least I knew it would run. It had no brakes. The seats and the door cards had been sliced with a knife. The story I was told was that two owners ago, an angry wife took a knife and sliced all of the seats and doors.

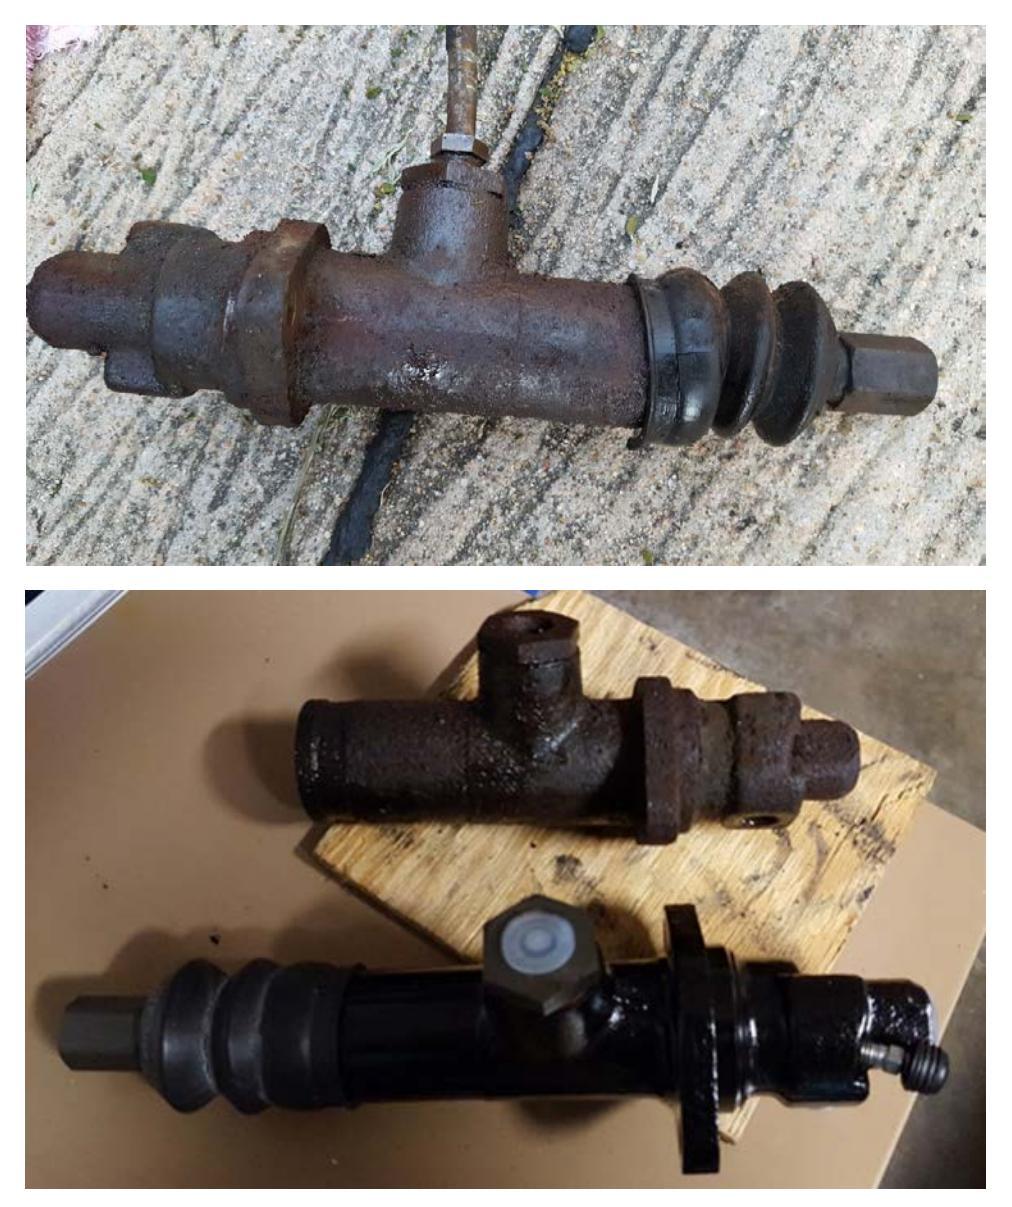
The car was transported to my house in Richardson, Texas but the truck could not make it through the alley to the rear of the house where the garage was. The master cylinder was shot and brake fluid just poured from it. My brother told me, "It looks like it came from the Titanic."

I replaced the master cylinder, bled the brakes, and replaced the fuel pump. That was enough to get the car started (and get it to stop), and with a rag under the carburetors, and a fire extinguisher in the front seat, I drove the car around to the driveway.

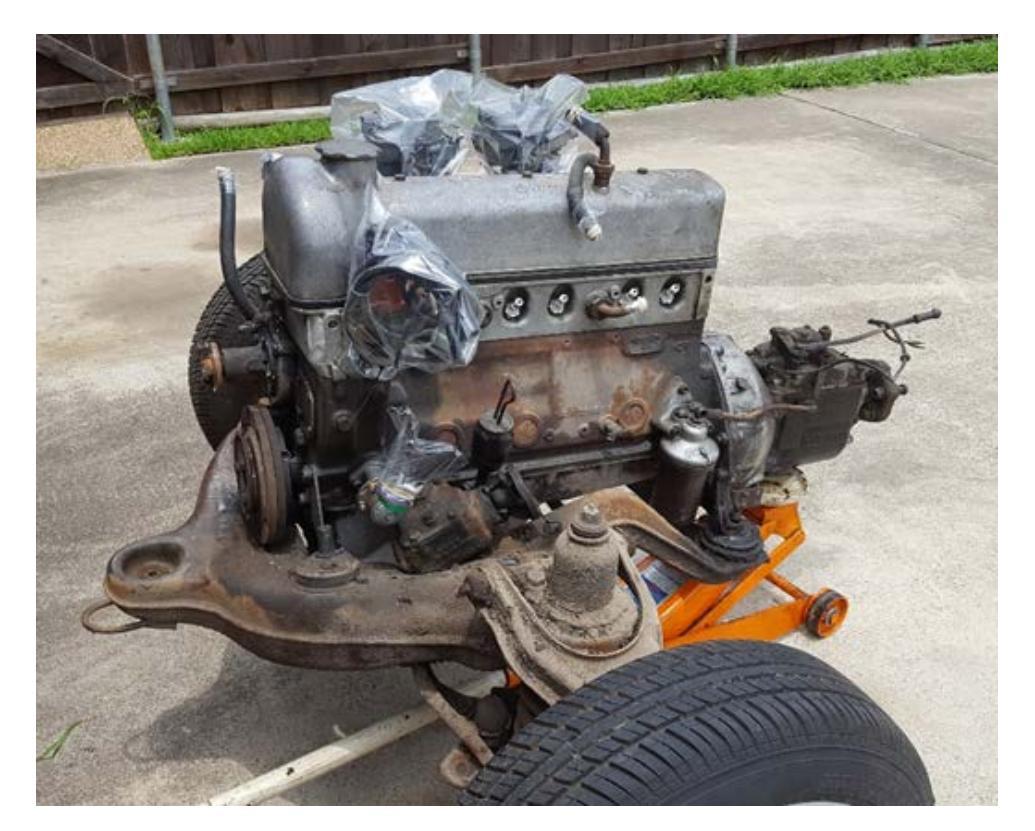
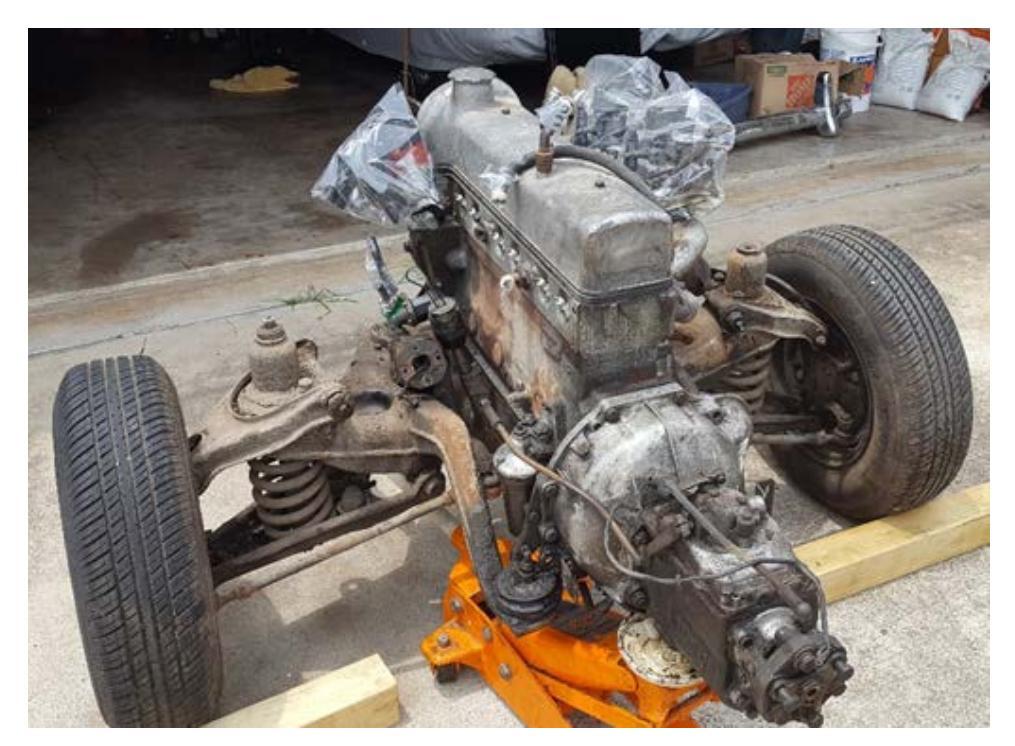
This is the separate U-shaped sub-frame (a.k.a. "Fahrschemel"), which is rubber mounted to the body shell at three points. It holds the engine, gearbox, suspension and recirculating ball steering.

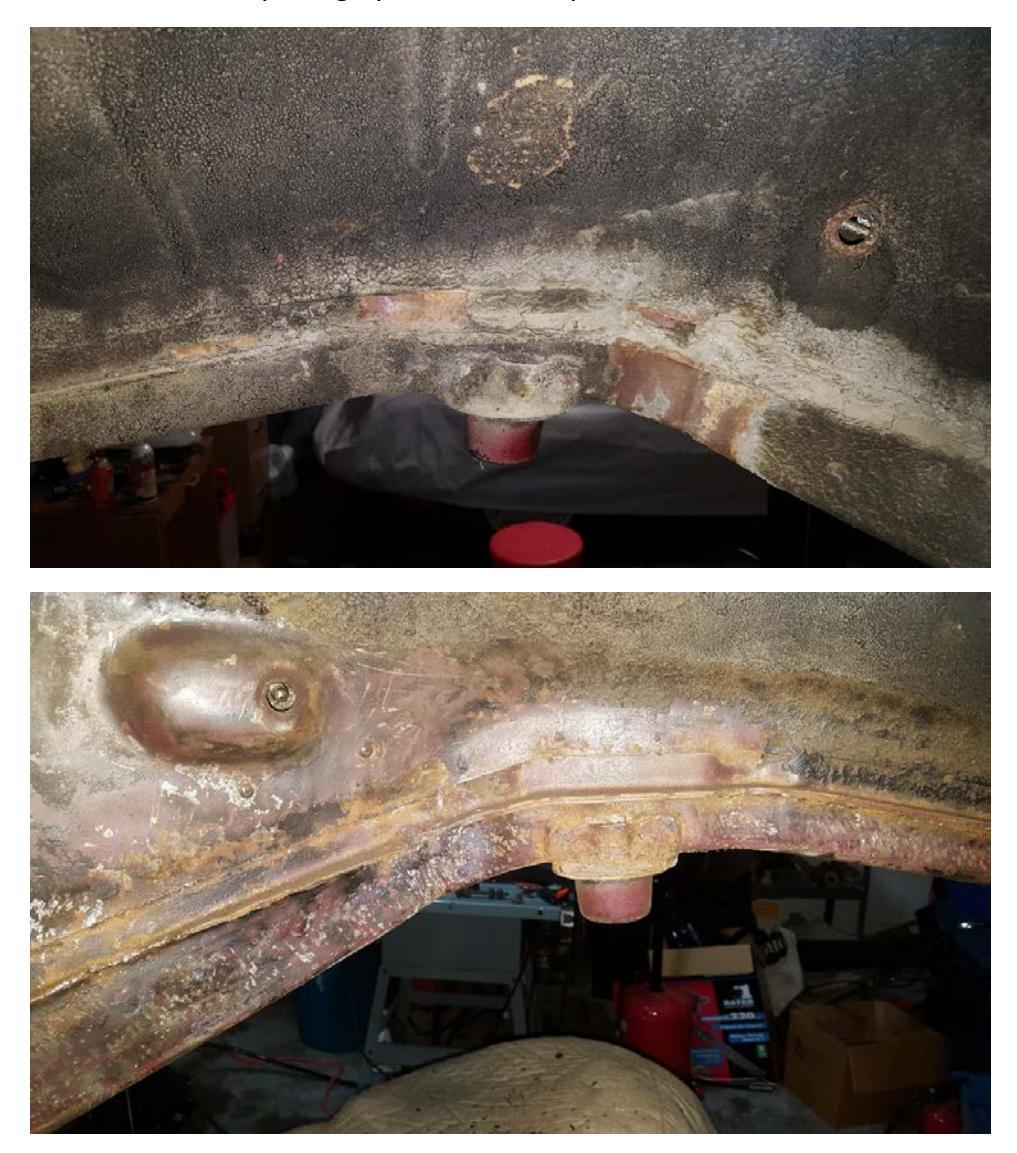
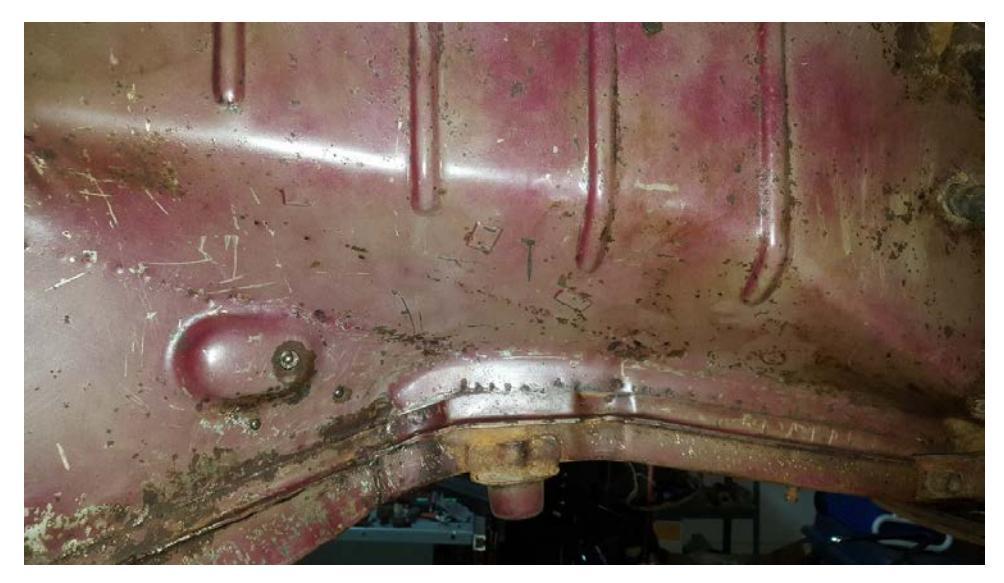
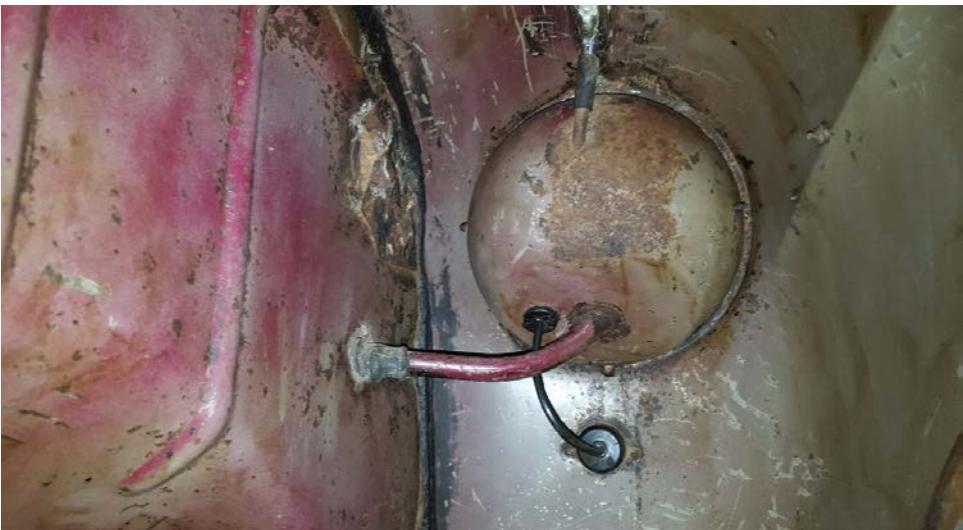
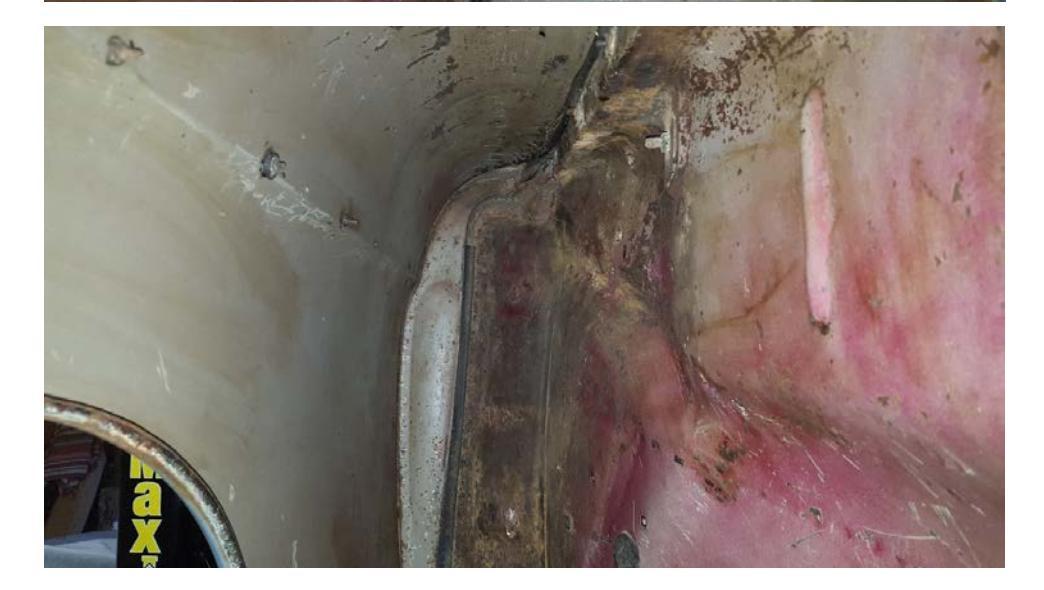
Next came the fender wells. The car had Ziebart rust protection (undercoating). Using a heat gun and scraper, I removed all of the undercoating. This left a 'film' behind that looked like oil tar. I was able to remove it by using Xylene and a respirator.

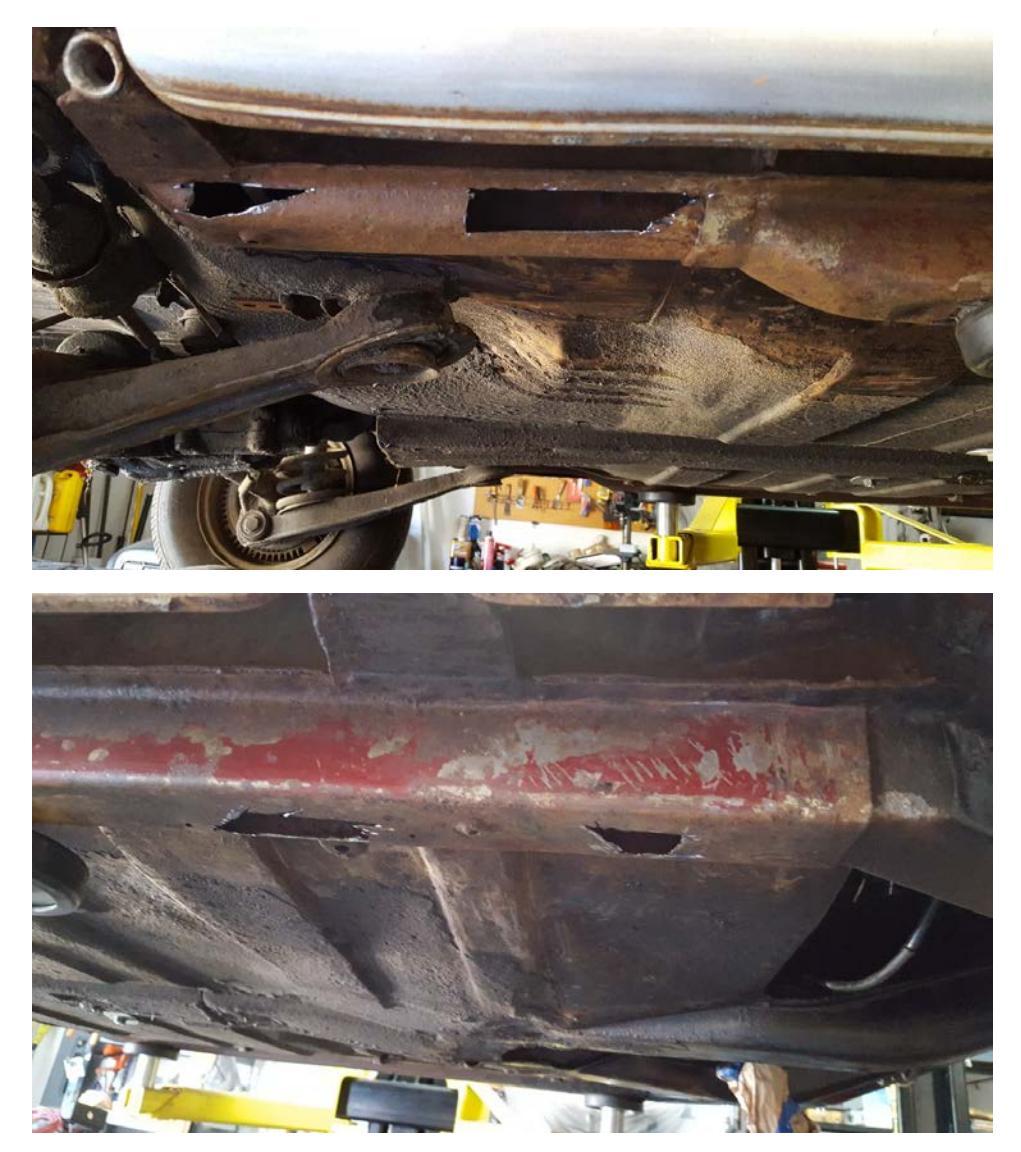
There were some small rust spots on the frame, so I cut the rust out and sprayed rust protection into the frame channels.

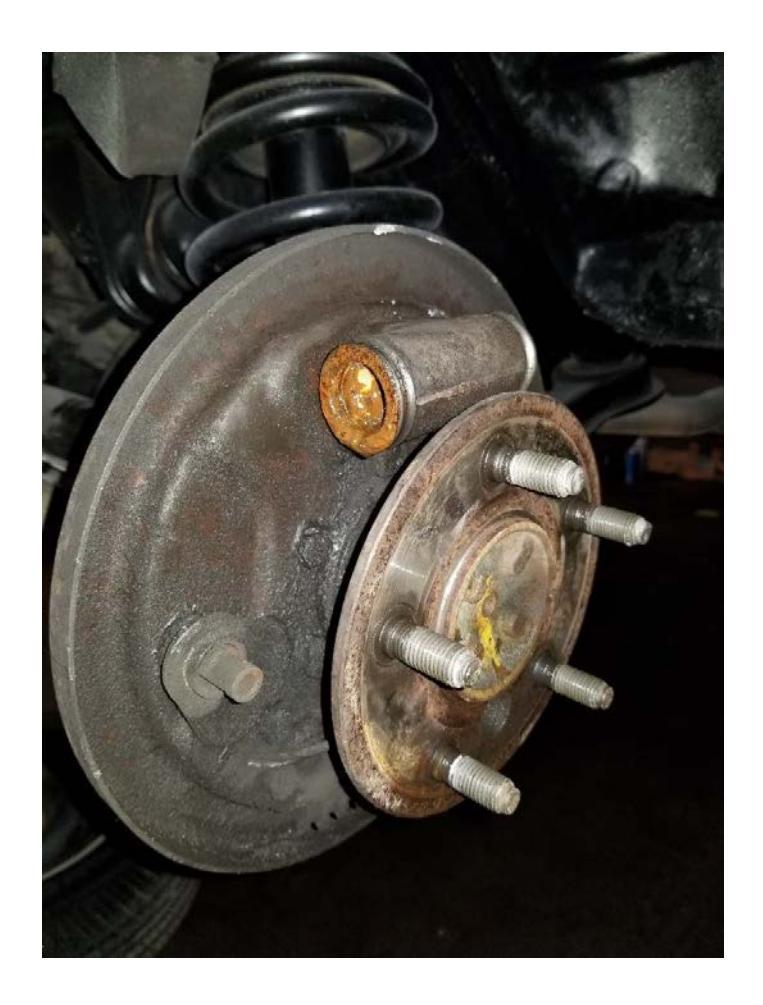
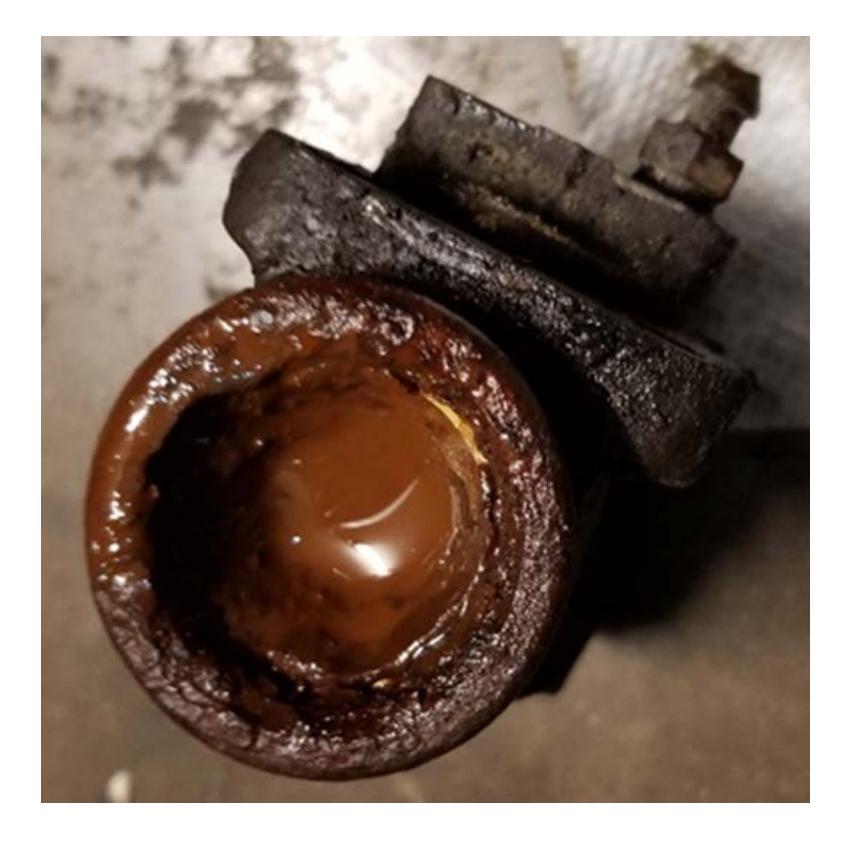
After noticing a leak in the front brake cylinder, I found that they had probably not been serviced since J.F.K. was a young senator.

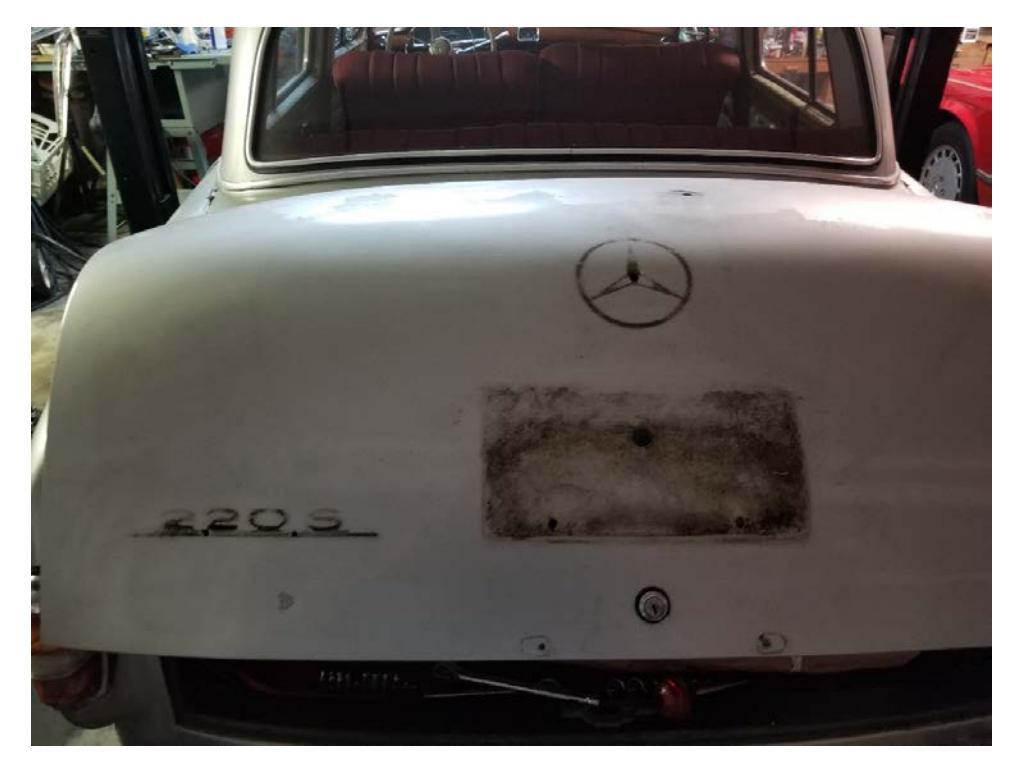
The badging was still visible after it was removed!

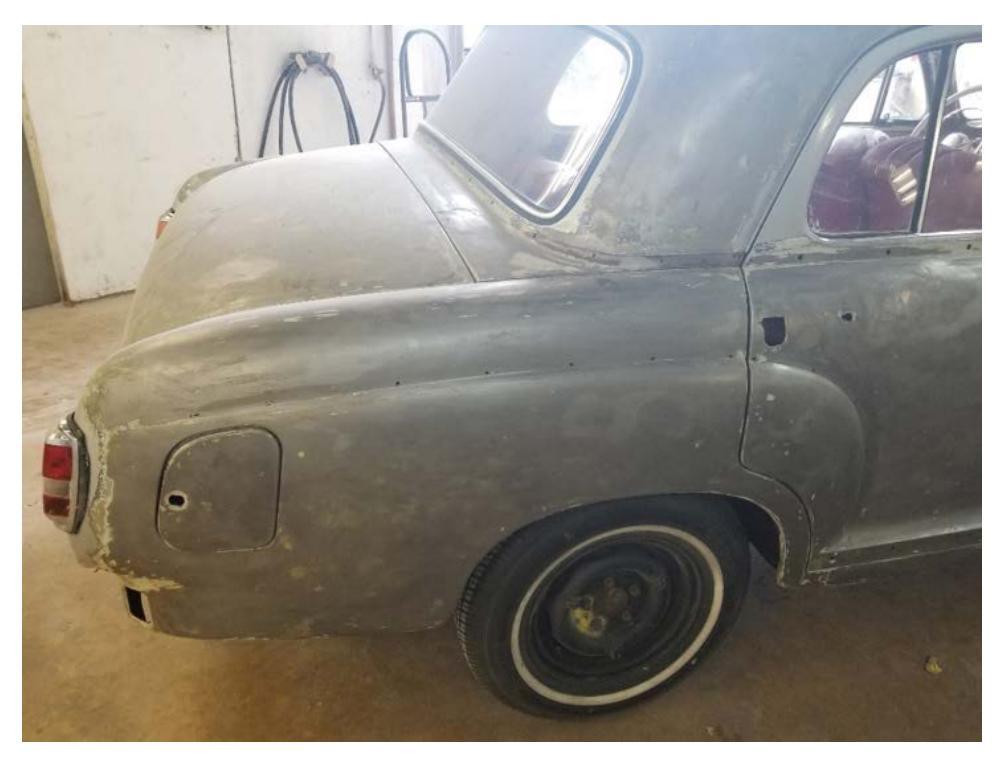
Down to bare metal:

Next came the body work. Mike and the folks at Best in Show started by stripping the car back to bare metal. It had 3 ½ coats of paint on it. The original maroon, two silver paint jobs, and another silver "Earl Scheib" paint job, which is why it only counted for ½.

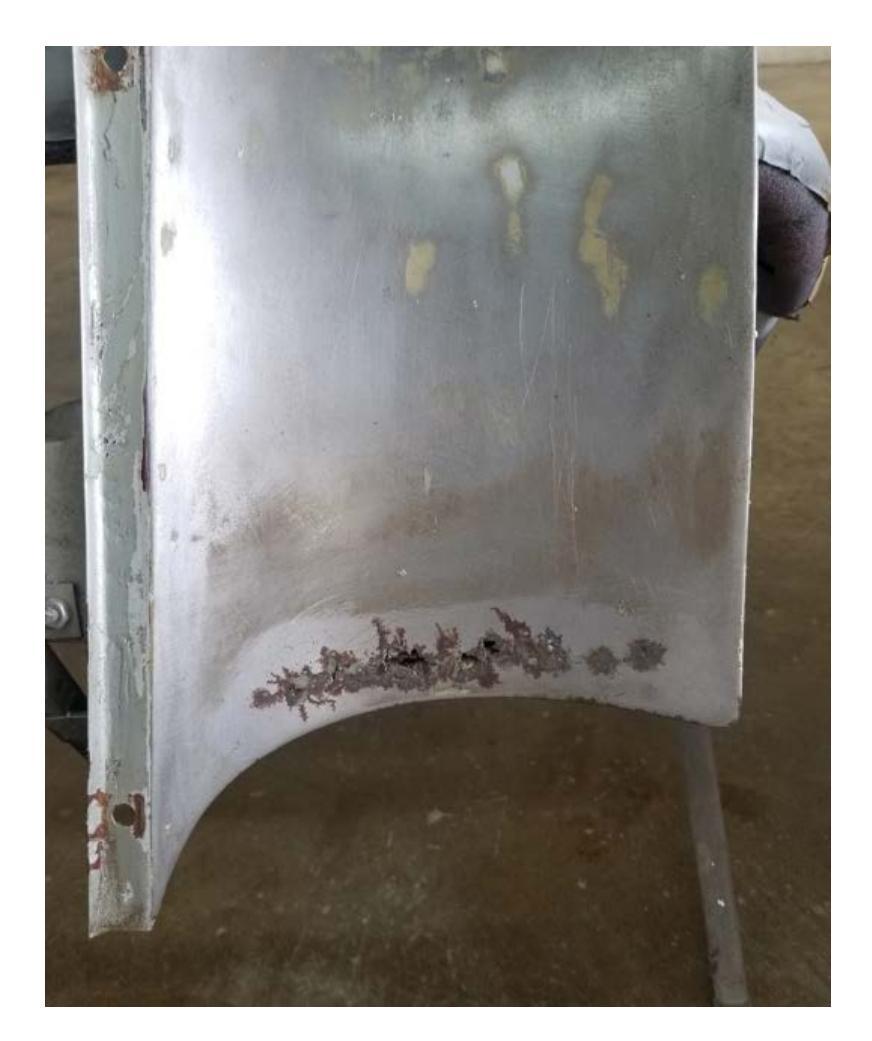
Rust on the lower edges of the hood had to be repaired. New metal, no filler. Also welded the frame opening that I cut out.
